**CLEGHORN**

## COLUMN REFURBISHMENT

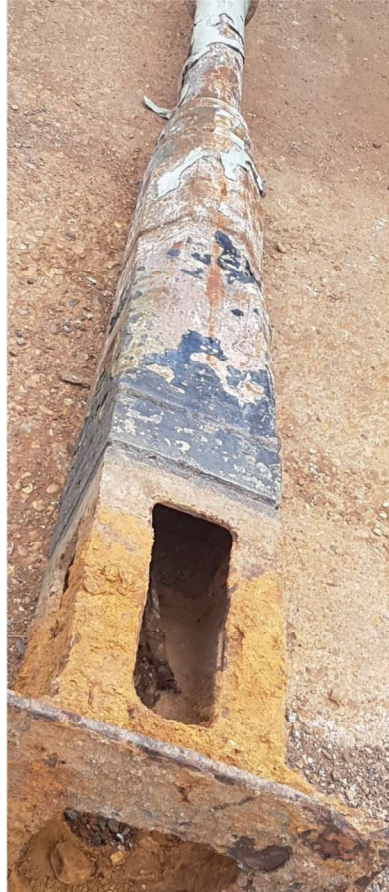
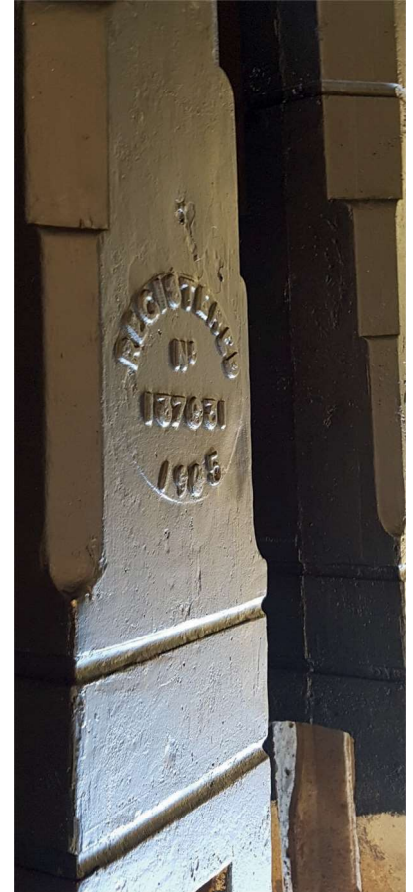
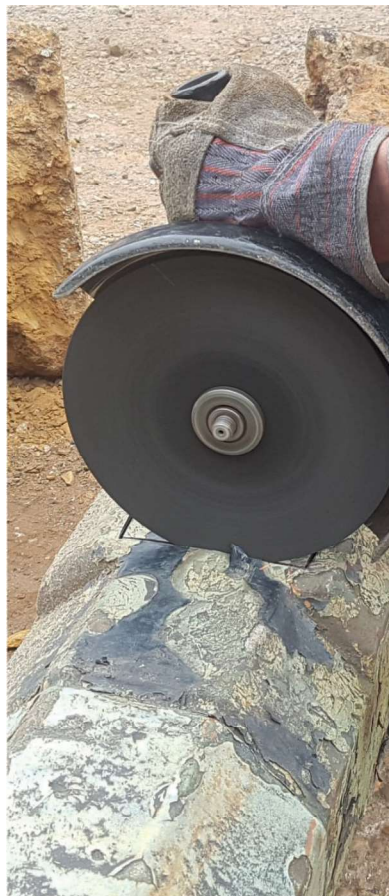
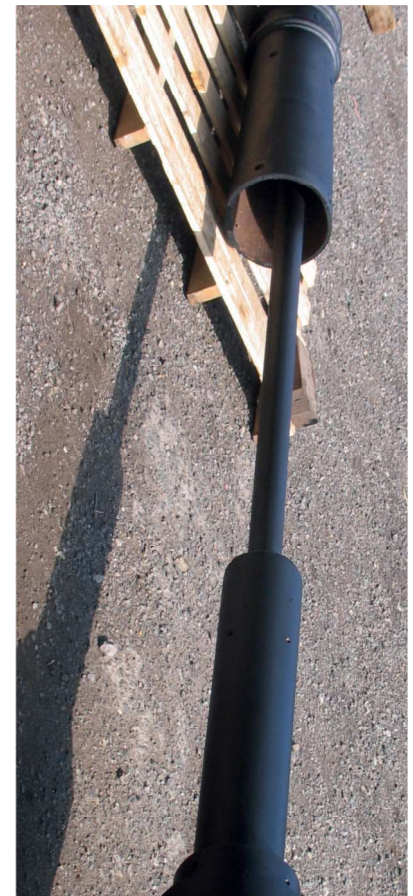
Your columns can be restored at our manufacturing facility where they would be shot blasted to remove old paint and rust. They are then etch primed and doors can be cut, if necessary, as well as any other enhancements before installation and painting on site.

Columns can also be restored on site where paint is removed carefully by hand. They are then re painted with a zinc rich etch primer (HBZP) and JC12 high gloss paint in your choice of colour. Cut doors can be added to retrofit electrics into heritage columns on site.

If your column has stress fractures, breaks or cracks, we can repair them with a new galvanised steel internal core. The core will reinforce the weakened column, making it safe for street usage. This is an ideal option if your column is unique or difficult to replace.
